PRIMARY RECORD

* Resource Name or #: 12291 Martha Ann Drive

Section 106 Compliance

Intensive Survey

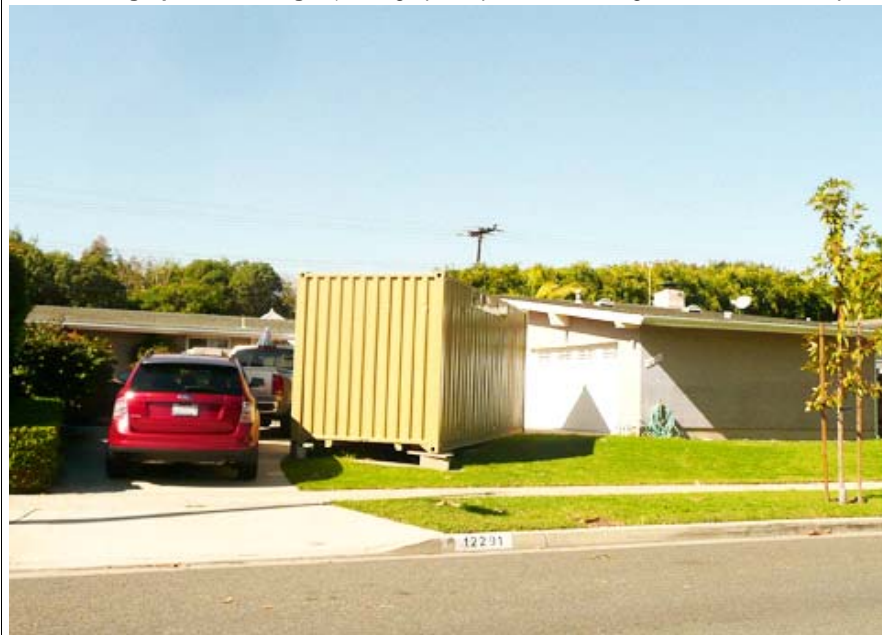
P1030841.jpg

* P3a. Description: (Describe resource and its major elements. Include design, materials, condition, alterations, size, setting, and boundaries.)
The one-story Post and Beam style building is 'L'-shaped in plan. The cross gabled roof, with exaggerated rafter detailing, is clad in composition shingles. A brick chimney is centrally located on the southern bay of the primary façade. The exterior walls are clad in smooth textured stucco, and the projecting eastern bay is also clad in brick veneer to the water line, which extends beyond the building to create a low battered wall. The window types opening onto the courtyard were not discernable from the public right of way, and amber-tinted pebble glass fixed-pane windows are located on the eastern façade of the projecting bay. Concrete screening block creates a central courtyard through which the primary entrance is accessed. The projecting bay contains a two-car garage, with pivot door. However, the Choate/ Kaltenbach buildings were designed as modular systems which could be expanded as needed, and the family room addition is in keeping with the design and materials of the building. Landscaping includes brick planters with immature shrubs and yuccas.

Facing west; 2/10/2010; Photo No.

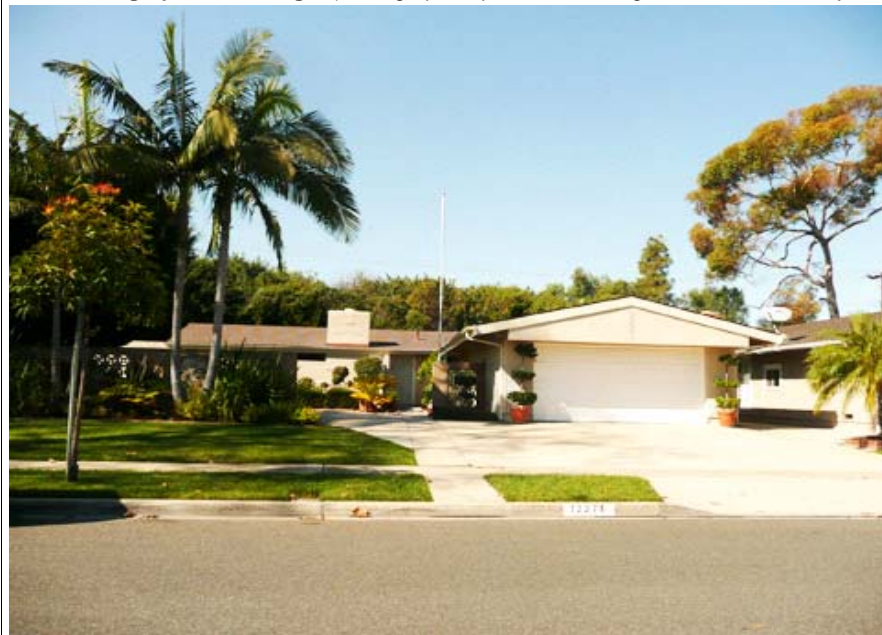
* P3a. Description: (Describe resource and its major elements. Include design, materials, condition, alterations, size, setting, and boundaries.)
The one-story Ranch style building is 'L'-shaped in plan. The cross gable roof is clad in composition shingles. A battered brick chimney is the primary focal point of the southern bay of the primary (eastern) façade. The exterior walls are clad in vertical wood siding, and the garage opening is accented with scored concrete. The metal casement and fixed-pane windows appear to be original. A concrete block and screen block wall encloses the front courtyard, and obscures details of the primary entryway. An attached two-car garage, with roll-up door, projects from the northern end of the primary (eastern) façade.

Facing west; 2/10/2010; Photo No.

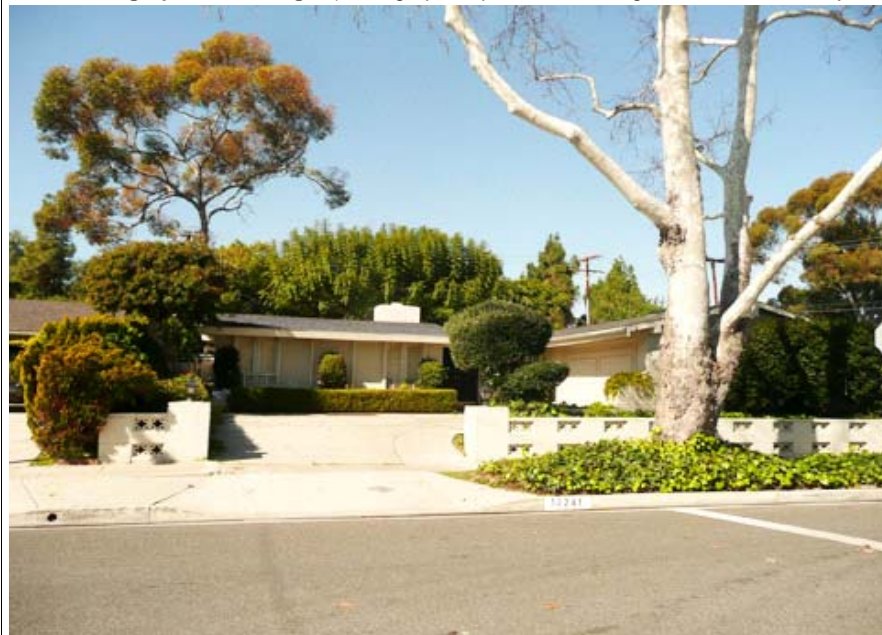
* P3a. Description: (Describe resource and its major elements. Include design, materials, condition, alterations, size, setting, and boundaries.)
The one-story Ranch style building is 'L'-shaped in plan. The cross gabled roof, with boxed eaves, is clad in composition shingles. A brick chimney is located at the northern end of the west face of the roof. The front-facing gable is accented with false beams. The exterior walls are clad in smooth textured stucco accentuated with batten. The eastern façade of the attached two-car garage is accented with brick veneer to the water line which extends beyond the building to create a battered wall. The aluminum fixed-pane and sliding windows appear to be original. The primary entrance is raised, and accessed via a tile-clad porch. The eastern perimeter of the front yard is accented with a low concrete block and screening block wall. The building does not meet the NRHP and CRHR eligibility criteria for the reasons identified on the district record prepared for this subdivision; therefore the building does not contribute to a historic district and is not individually eligible for listing in the NRHP and the CRHR.

Facing west; 2/10/2010; Photo No.

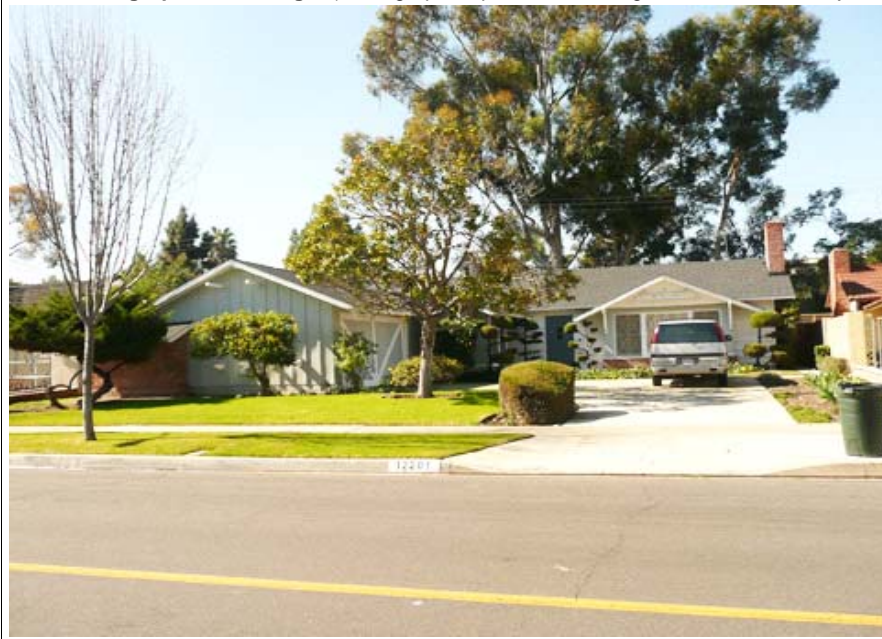
* P3a. Description: (Describe resource and its major elements. Include design, materials, condition, alterations, size, setting, and boundaries.)
The one-story Ranch style building is 'L'-shaped in plan. The cross gabled roof is clad in composition shingles. A brick chimney is located on the northern façade. The northern gable on the primary (eastern) façade is accented with a dove-cote and triangulated knee brackets. The southern bay of the primary (eastern) façade is accented with false beams, and a half-height projecting bay partially spans the eastern end of the bay. The half-height bay is characterized by a composition shingle clad pent roof and brick veneer. The diamond paned one-over-one wood sash, sliding, and fixed-pane windows appear to be original. The primary entrance is at grade. An attached two-car garage, with pivot door accented with false timbering, projects from the southern end of the primary (eastern) façade. Landscape includes topiaries and an immature tree in the parkway.

Facing west; 2/10/2010; Photo No.

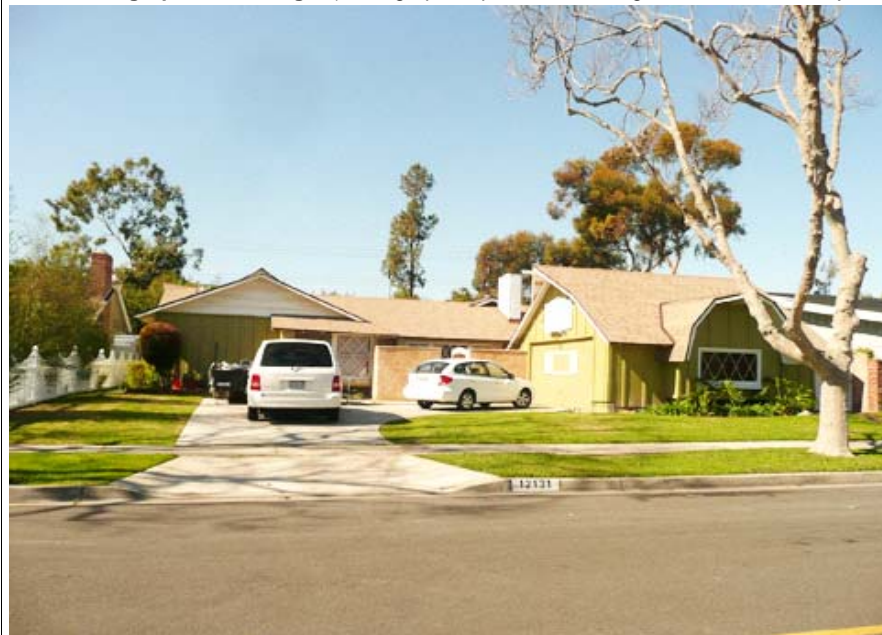
* P3a. Description: (Describe resource and its major elements. Include design, materials, condition, alterations, size, setting, and boundaries.)
The one-story Ranch style building is generally rectangular in plan. The cross gabled roof, with flared gable heads, is clad in composition shingles. A brick chimney is located the northern end of the east face of the roof. The gables are clad in wavy-edge horizontal wood siding, and the exterior walls are clad in vertical board and batten siding and rough textured stucco, which appears to be an alteration. The diamond-pane wood sash and fixed-pane windows appear to be original. A modern concrete block wall with rough textured stucco creates a courtyard and obscures other details of the building. A barn-style detached garage is located in the front of the parcel. The rectangular building is characterized by a front-gabled roof, with gambrel dormers clad in composition shingles, vertical board and batten siding, a faux hayloft over the wood pivoting access door, and a diamond-pane fixed-pane window with amber-tinted pebble glass.

P5b. Description of Photo: (View, date, etc.)
Facing the primary façade; 2/10/2010; Photo No. P1030845.jpg

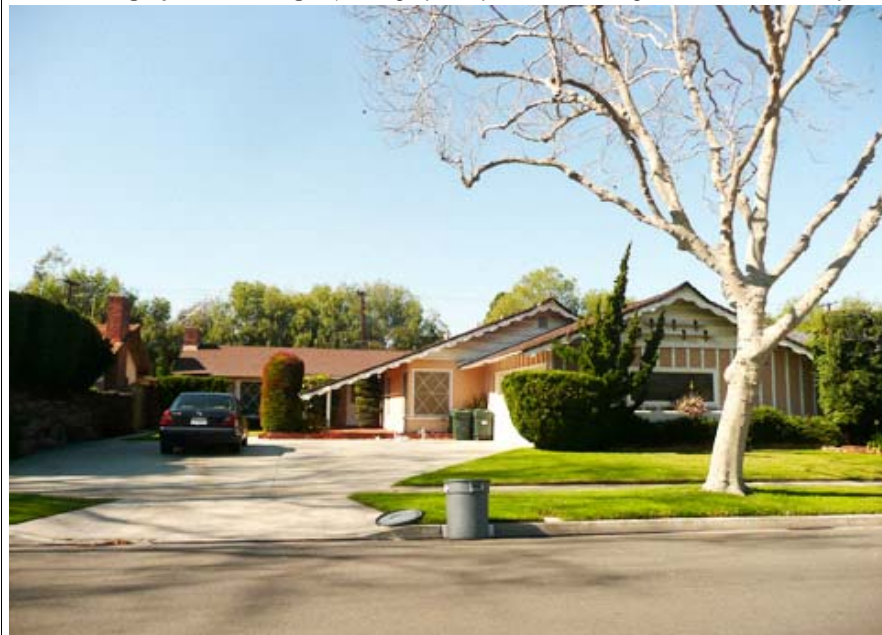
* P3a. Description: (Describe resource and its major elements. Include design, materials, condition, alterations, size, setting, and boundaries.)
The one-story Storybook Ranch style building is generally 'L'-shaped in plan. The cross gable roof, with flared gables, is clad in composition shingles. The gables are accented with scalloped barge board, horizontal wood siding, and the easternmost gable is further accented with a dove-cote. A brick chimney is centrally located on the southern elevation. The exterior walls are clad in smooth textured stucco, with false timbering in the eastern elevation of the northern gable. The diamond-paned one-over-one wood sash and fixed-pane windows appear to be original. The primary entrance is raised, and accessed via a tile-clad cast concrete porch. The roof overhangs to shelter the entryway, and is supported by a square wood post.

Facing west; 2/10/2010; Photo No.

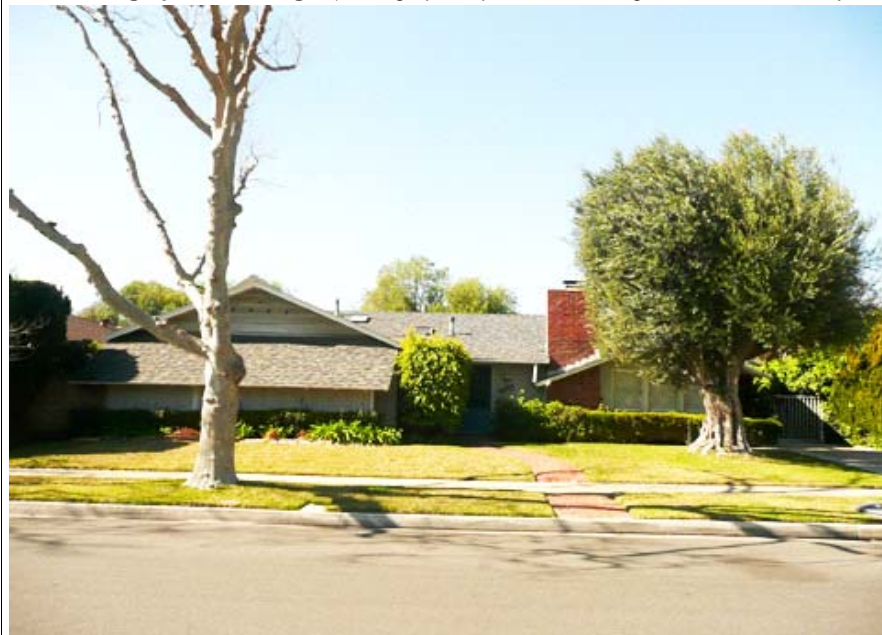
* P3a. Description: (Describe resource and its major elements. Include design, materials, condition, alterations, size, setting, and boundaries.)
The one-story Ranch style building is 'U'-shaped in plan. The cross gable on hip roof, with flared gables, is clad in composition shingles. Skylights are scattered on the east face of the roof. The gables are accented with horizontal wood siding and the southern gable is further accented with a doveote. A brick chimney is located near the northern end of the primary (eastern) façade. The exterior walls are clad in board and batten wood siding and smooth textured stucco. A small half-height bay, with pent roof, spans the east face of the southern bay of the primary (eastern) façade. The diamond pane, one-over-one wood sash windows appear to be original. The primary entrance is raised, recessed, and accessed via a cast concrete porch. Landscaping includes brick planters, a mature olive tree, and a mature sycamore in the parkway.

Facing west; 2/10/2010; Photo No.

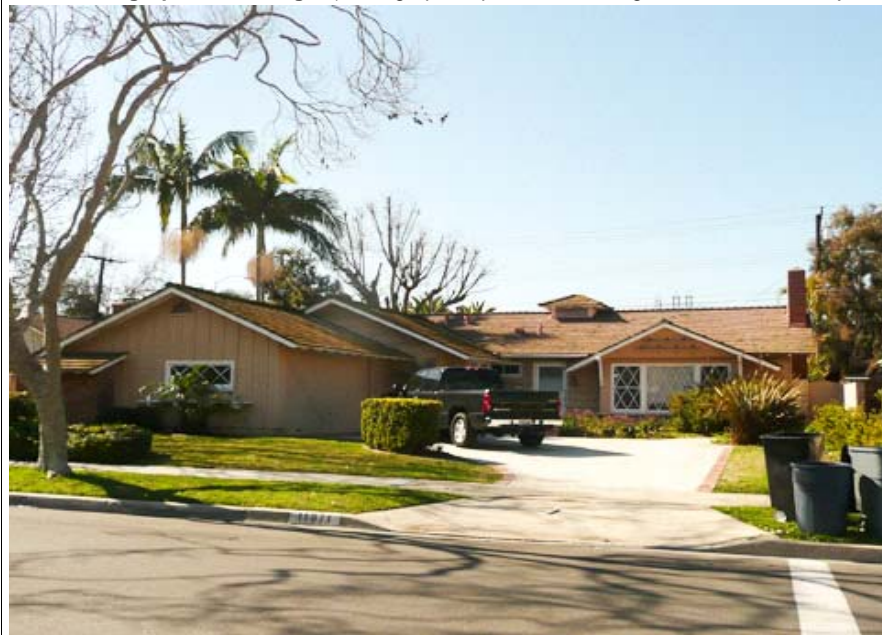
* P3a. Description: (Describe resource and its major elements. Include design, materials, condition, alterations, size, setting, and boundaries.)
The one-story Ranch style building is 'L'-shaped in plan. The cross gabled roof, with boxed eaves and exposed rounded rafter tails, is clad in composition shingles. A cupola is centrally located on the roof crest, and a brick chimney is located on the northern façade of the building. The northern front-facing gable is accented with brackets and a doveote. The exterior walls are clad in vertical board and batten siding, smooth textured stucco, and horizontal wood siding. The diamond-paned sash and fixed-paned wood windows appear to be original, and at least one window has been replaced with a vinyl sliding unit. The diamond-paned fixed-pane window with amber tinted pebble glass located on the eastern façade of the attached two-car garage is accented with a flowerbox ledge, and a bay with brick veneer and a half-height pent roof partially spans this facade. The primary entrance is raised, and accessed via a cast concrete porch. The building does not meet the NRHP and CRHR eligibility criteria for the reasons identified on the district record prepared for this subdivision; therefore the building does not contribute to a historic district and is not individually eligible for listing in the NRHP and the CRHR.

Facing west; 2/10/2010; Photo No.

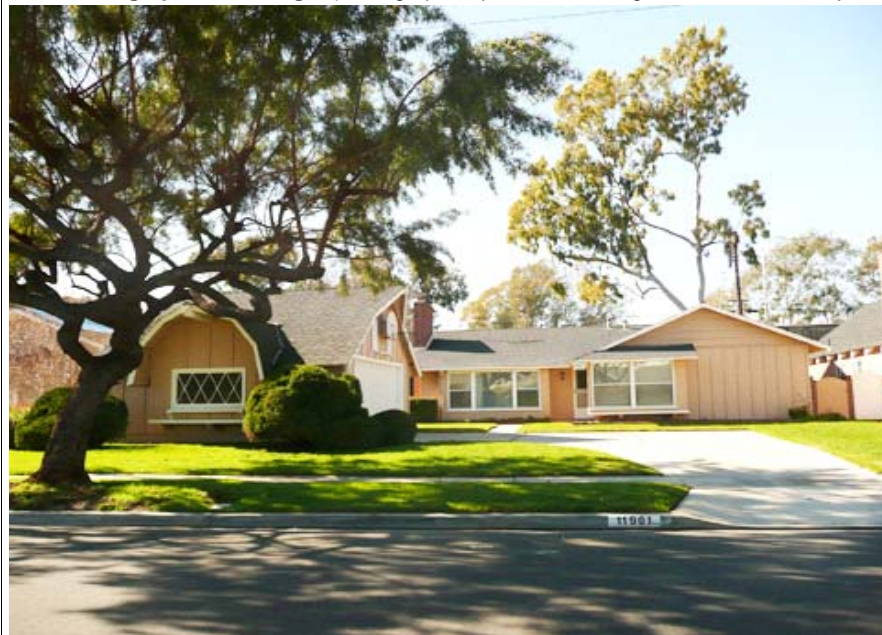
* P3a. Description: (Describe resource and its major elements. Include design, materials, condition, alterations, size, setting, and boundaries.)
The one-story Ranch style building is 'L'-shaped in plan. The cross gabled roof, with partial gable on hip roof, is clad in composition shingles. A brick chimney is located off-center on the east face of the roof. The exterior walls are clad in board and batten siding, smooth textured stucco, and horizontal wood siding in the front-facing gable. The windows were replaced with vinyl sash and fixed-pane windows at an unknown date. A projecting bay partially spans the east and south facades of the northern bay of the primary (eastern) façade, and is accented with corbels. The primary entrance is raised, and is accessed via a cast concrete porch. A detached two-car garage is located in the front of the parcel. The garage is characterized by a front gabled roof, with gambrel dormers with false beams, clad in composition shingles, vertical board and batten siding, and a diamond-paned fixed-pane window with brackets and a flowerbox ledge. The building does not meet the NRHP and CRHR eligibility criteria for the reasons identified on the district record prepared for this subdivision; therefore the building does not contribute to a historic district and is not individually eligible for listing in the NRHP and the CRHR.

Facing west; 2/10/2010; Photo No.

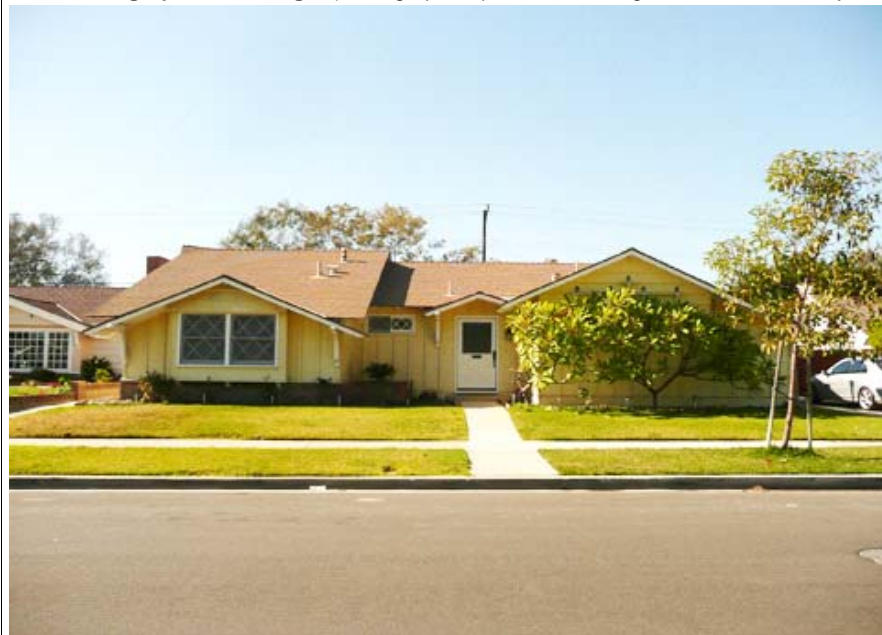
* P3a. Description: (Describe resource and its major elements. Include design, materials, condition, alterations, size, setting, and boundaries.)
The one-story Ranch style building is 'U'-shaped in plan. The multi-gabled roof, with flared gable heads and boxed eaves, is clad in composition shingles. The southern and central front-facing gables are accented with brackets, and the northern front-facing gable is accented with a dove-cote and horizontal wood siding. The exterior walls are clad in vertical board and batten siding, and the southern bay of the primary (eastern) façade is accented with brick veneer to the water line. The southern bay of the primary (eastern) façade is further accented with a projecting bay clad in horizontal wood siding and corbels. The diamond-paned wood sash and sliding windows appear to be original. The primary entrance is raised and accessed via a cast concrete porch. The building does not meet the NRHP and CRHR eligibility criteria for the reasons identified on the district record prepared for this subdivision; therefore the building does not contribute to a historic district and is not individually eligible for listing in the NRHP and the CRHR.

Facing west; 2/10/2010/ Photo No.

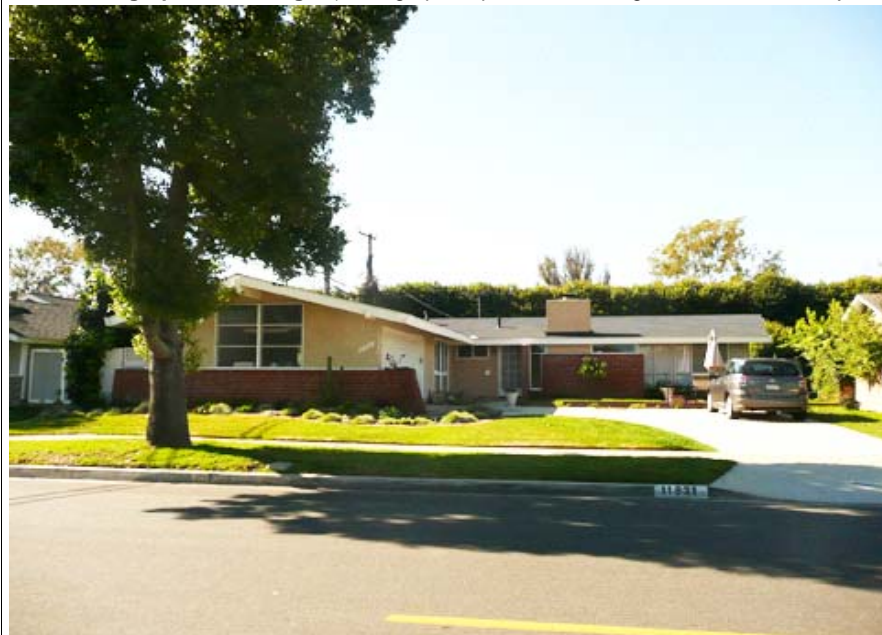
* P3a. Description: (Describe resource and its major elements. Include design, materials, condition, alterations, size, setting, and boundaries.)
The one-story Ranch style building is 'L'-shaped in plan. The cross gabled roof, with boxed eaves, is clad in composition shingles. The front-facing gable is accented with false beams. A brick chimney is prominently located on the northern bay of the primary (eastern) façade. The exterior walls are clad in smooth textured stucco, and the eastern façade of the attached two-car garage is accented with brick veneer to the water line which extends beyond the building to create a battered wall. Some of the original aluminum fixed-pane and casement windows are extant, and some have been replaced with vinyl units. The six-light fixed-pane window located on the eastern façade of the garage is accented with pebble glass. The primary entrance is raised and accessed via a cast concrete porch. A brick wall partially encloses the primary entry porch. The building does not meet the NRHP and CRHR eligibility criteria for the reasons identified on the district record prepared for this subdivision; therefore the building does not contribute to a historic district and is not individually eligible for listing in the NRHP and the CRHR.

Facing west; 2/10/2010; Photo No.

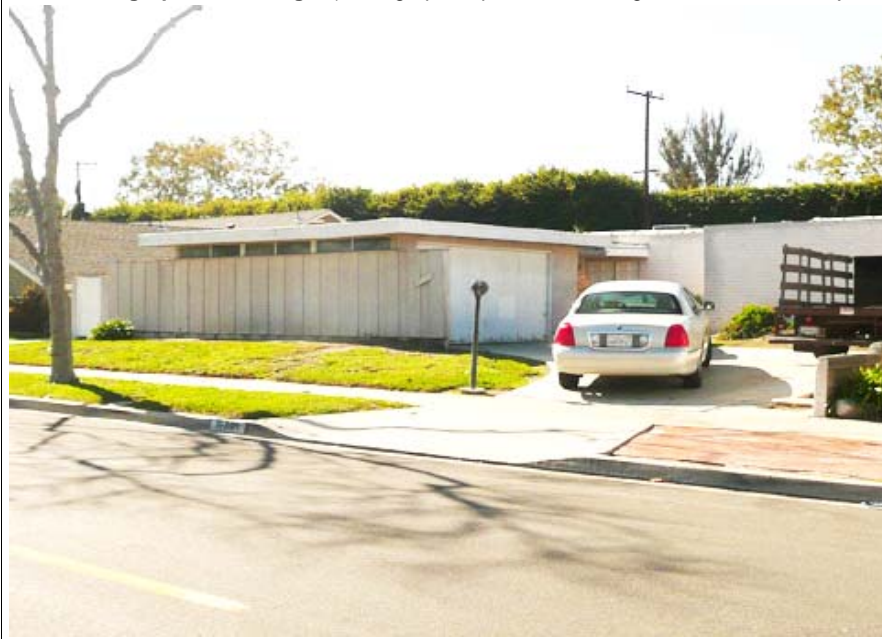
* P3a. Description: (Describe resource and its major elements. Include design, materials, condition, alterations, size, setting, and boundaries.)
The one-story Ranch style building is rectangular in plan. The flat roof is clad in an unknown material. The primary façade of this building is a largely monolithic brick wall. A double-acting primary entry door appears to be centrally located on the primary façade. A detached two-car garage is located in the front of the parcel and is connected to the main building by a breezeway. A band of aluminum sliding windows and board and batten siding, which extends beyond the wall of the garage, accent the eastern façade of the garage. Other details are not discernable from the public right of way. The building does not meet the NRHP and CRHR eligibility criteria for the reasons identified on the district record prepared for this subdivision; therefore the building does not contribute to a historic district and is not individually eligible for listing in the NRHP and the CRHR.

P5b. Description of Photo: (View, date, etc.)
Facing the primary façade; 2/10/2010; Photo No. P1030854.jpg

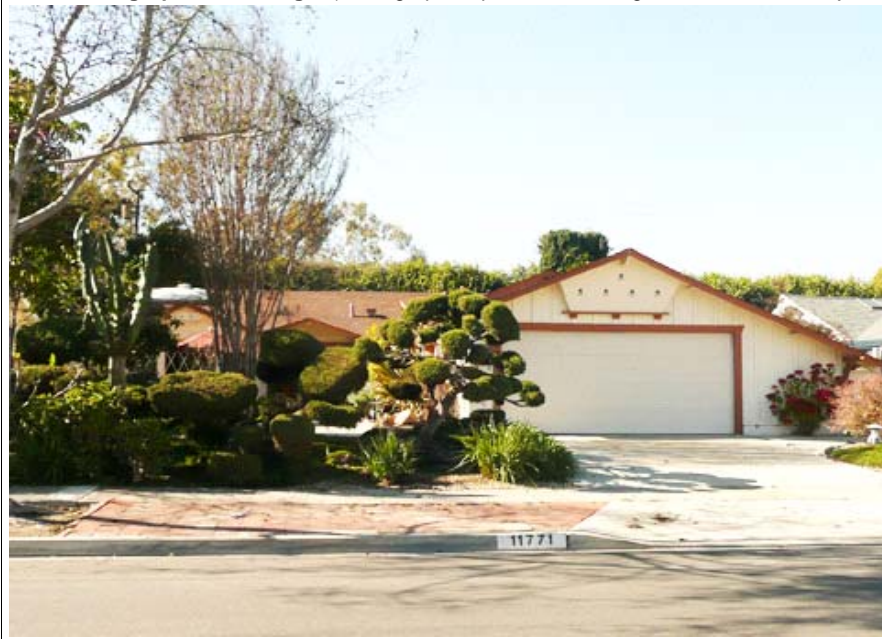
* P3a. Description: (Describe resource and its major elements. Include design, materials, condition, alterations, size, setting, and boundaries.)
The one-story Ranch style building is 'L'-shaped in plan. The cross gabled roof, with boxed eaves, is clad in composition shingles. The northernmost and southernmost front-facing gables are accented with dove-cotes, and the southern and central front-facing gables are clad in horizontal wood siding. A bubble skylight is located on the southern end of the east face of the roof, and appears to be an alteration. The exterior walls are clad in vertical board and batten siding and vertical wood siding. The diamond-paned wood sash and fixed-pane windows appear to be original. The primary entrance is accessed via a covered cast concrete porch. The building does not meet the NRHP and CRHR eligibility criteria for the reasons identified on the district record prepared for this subdivision; therefore the building does not contribute to a historic district and is not individually eligible for listing in the NRHP and the CRHR.

Facing west; 2/10/2010; Photo No.

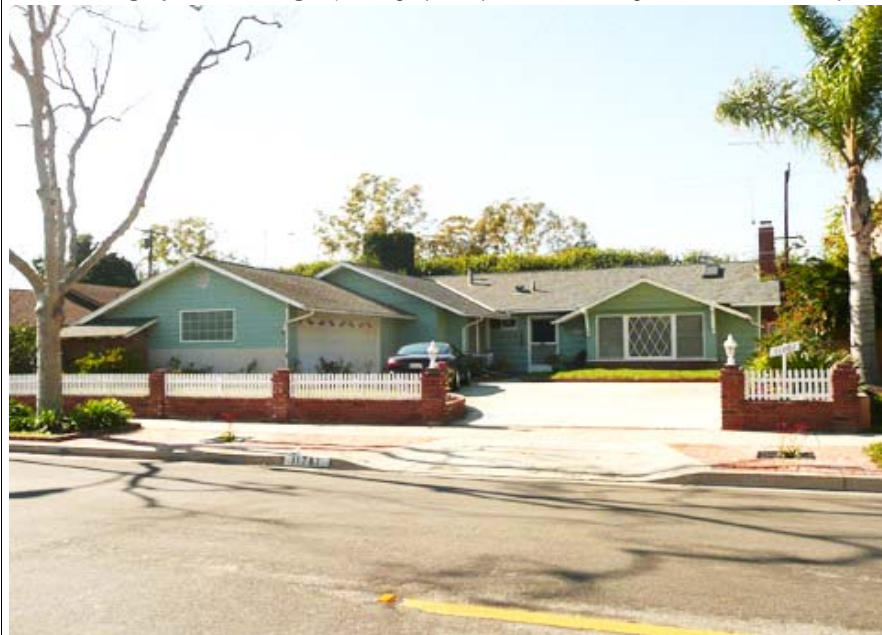
* P3a. Description: (Describe resource and its major elements. Include design, materials, condition, alterations, size, setting, and boundaries.)
The one-story Ranch style building is 'L'-shaped in plan. The cross gabled roof, with boxed eaves, is clad in composition shingles. The northern front-facing gable is accented with brackets. A brick chimney is located on the northern façade of the building. The exterior walls are clad in horizontal wood siding. The projecting bay on the northern end of the primary (eastern) façade is accented with brick veneer to the water line, and the east façade of the attached two-car garage is accented with smooth textured stucco to the water line. The diamond-paned wood sash and fixed-pane windows appear to be original, and the fixed-pane window on the east façade of the garage was replaced with a vinyl unit at an unknown date. A half-height projecting bay clad in brick veneer with a pent roof partially spans the southern end of the eastern facade of the attached garage. A brick and metal fence encloses the perimeter of the parcel. The building does not meet the NRHP and CRHR eligibility criteria for the reasons identified on the district record prepared for this subdivision; therefore the building does not contribute to a historic district and is not individually eligible for listing in the NRHP and the CRHR.

Facing west; 2/10/2010; Photo No.

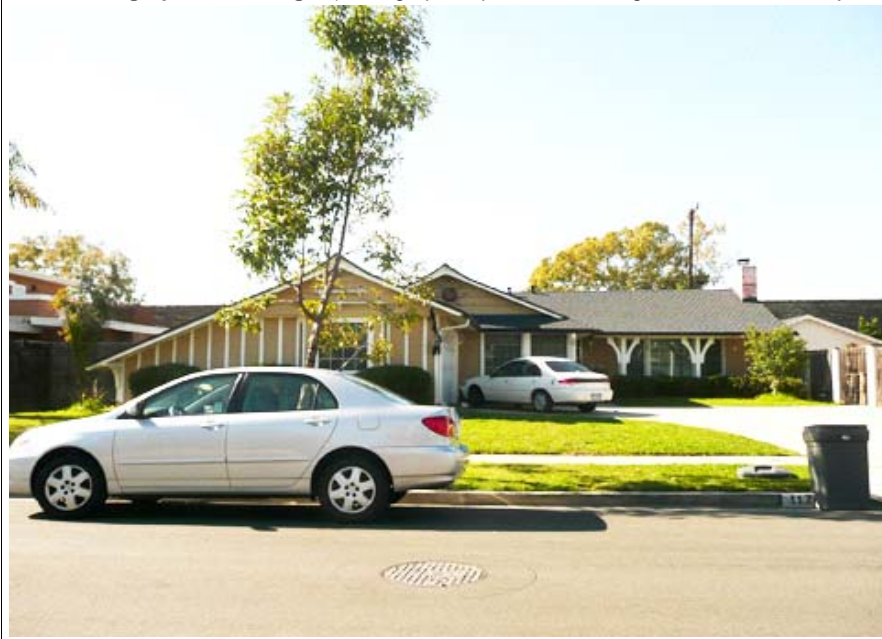
* P3a. Description: (Describe resource and its major elements. Include design, materials, condition, alterations, size, setting, and boundaries.)
The one-story Ranch style building is 'L'-shaped in plan. The cross gabled/gable on hip roof, with flared gable heads and boxed eaves, is clad in composition shingles. The A brick chimney is located on the northern façade of the building. The front-facing gable of the attached two-car garage is asymmetrical, and accented with brackets, a dovetail, horizontal wood siding in the gable, and vertical board and batten siding. The central front-facing gable is clad in vertical wood siding. The exterior walls of the building are clad in smooth textured stucco. The windows were replaced with vinyl sash and fixed-pane units at an unknown date. The primary entrance is accessed via a covered cast concrete porch, which spans the northern bay of the primary (eastern) façade. The porch roof is supported by square wood posts with decorative brackets. The building does not meet the NRHP and CRHR eligibility criteria for the reasons identified on the district record prepared for this subdivision; therefore the building does not contribute to a historic district and is not individually eligible for listing in the NRHP and the CRHR.

Facing west; 2/10/2010; Photo No.

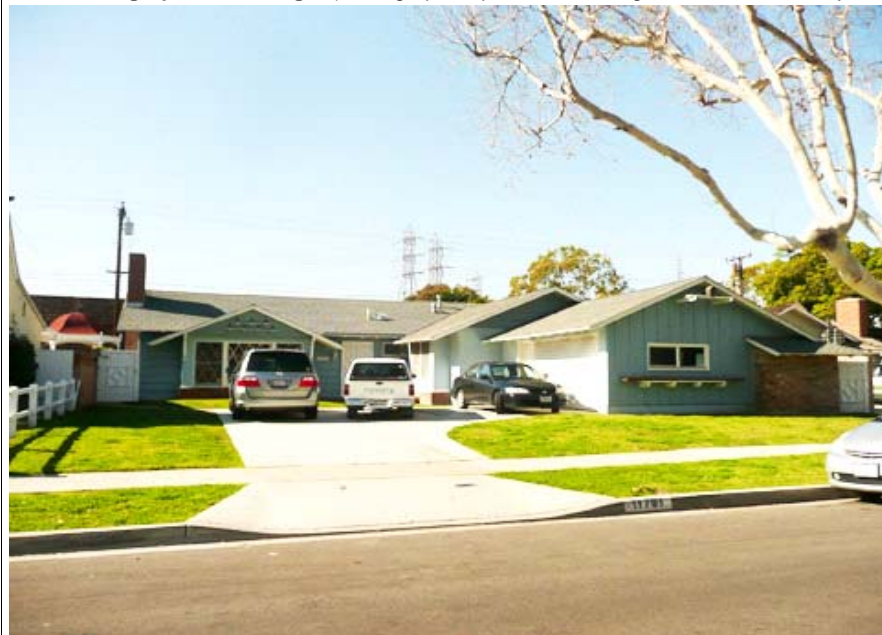
* P3a. Description: (Describe resource and its major elements. Include design, materials, condition, alterations, size, setting, and boundaries.)
The one-story Ranch style building is 'L'-shaped in plan. The cross gabled roof, with boxed eaves, is clad in composition shingles. A brick chimney is located on the southern façade of the building. The southern front-facing gable is accented with brackets and a doveote, and the northern front-facing gable is accented with a flowerbox ledge. The exterior walls are clad in horizontal wood siding, smooth textured stucco, and vertical board and batten siding. The projecting bay on the southern end of the primary (eastern) façade and the south-facing central bay are accented with brick veneer to the water line. The eastern façade of the northern bay is accented with a half-height projecting bay clad in brick veneer with a composition shingle-clad pent roof which partially spans the northern end of the façade. The diamond-paned wood sash and fixed-pane windows appear to be original. The window located on the eastern façade of the attached garage was replaced with a vinyl sliding unit, and is accented with a flowerbox ledge.

Facing west; 2/10/2010; Photo No.

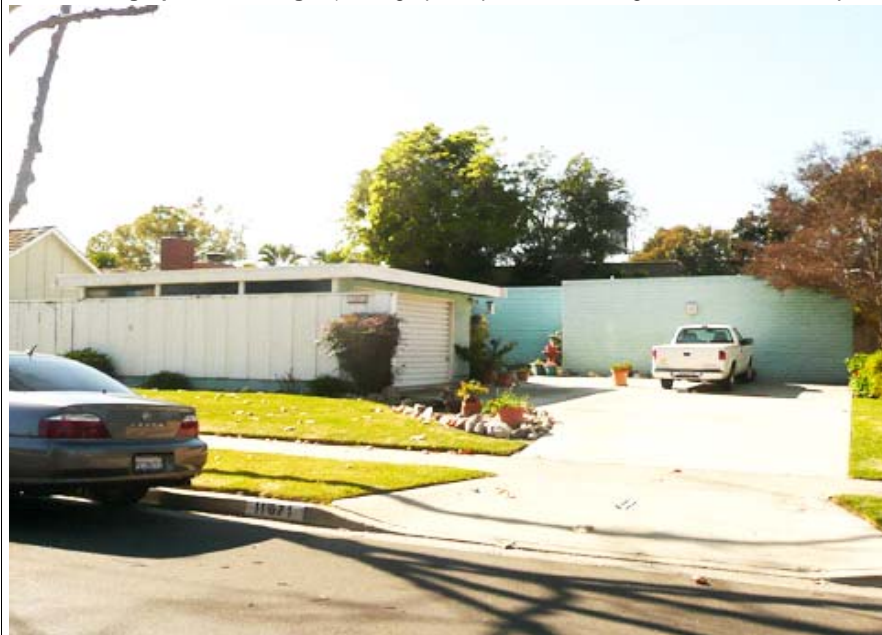
* P3a. Description: (Describe resource and its major elements. Include design, materials, condition, alterations, size, setting, and boundaries.)
The one-story Ranch style building is rectangular in plan. The flat roof is clad in an unknown material. The primary façade of this building is a largely monolithic brick wall. A double-acting primary entry door appears to be centrally located on the primary façade. A detached two-car garage is located in the front of the parcel and is connected to the main building by a breezeway. A band of aluminum sliding windows and board and batten siding, which extends beyond the wall of the garage, accent the eastern façade of the garage. Other details are not discernable from the public right of way.

P5b. Description of Photo: (View, date, etc.)
Facing the primary façade; 2/10/2010; Photo No. P1030859.jpg

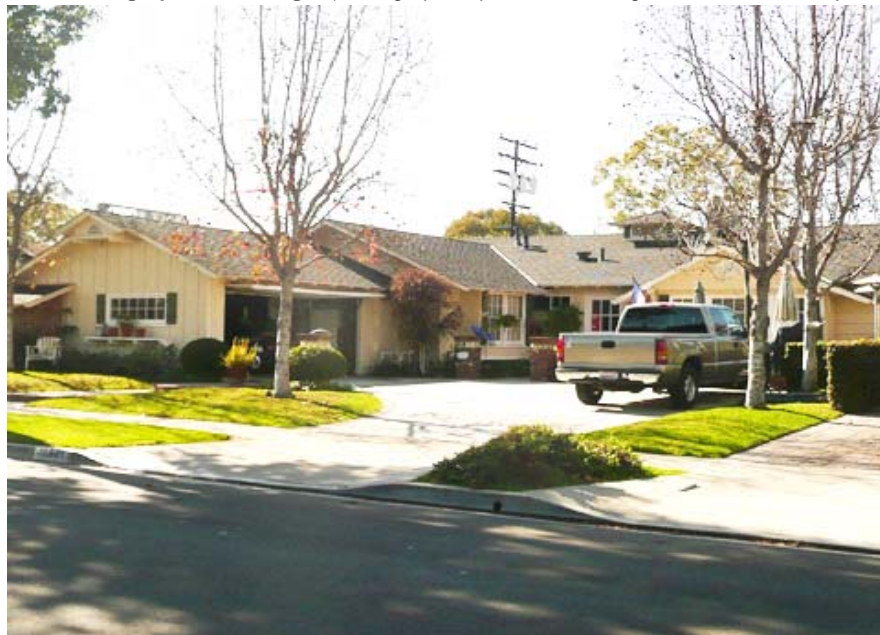
* P3a. Description: (Describe resource and its major elements. Include design, materials, condition, alterations, size, setting, and boundaries.)
The one-story Ranch style building is 'L'-shaped in plan. The cross gabled roof, with boxed eaves, is clad in composition shingles. A cupola is centrally located on the roof crest. The eastern front-facing gable on the attached two-car garage is accented with a flowerbox ledge, and the gable is shaped to imply a dovecote. The exterior walls are clad in board and batten siding, smooth textured stucco with brick veneer to the water line, and horizontal wood siding. The windows were replaced with vinyl sash units. The east façade of the garage is accented with a vinyl fixed-pane window accented with shutters and a flowerbox ledge, and a half-height projecting bay clad in brick veneer with a composition shingle-clad pent roof.

P5b. Description of Photo: (View, date, etc.)
Facing the primary façade; 2/10/2010; Photo No. P1030860.jpg

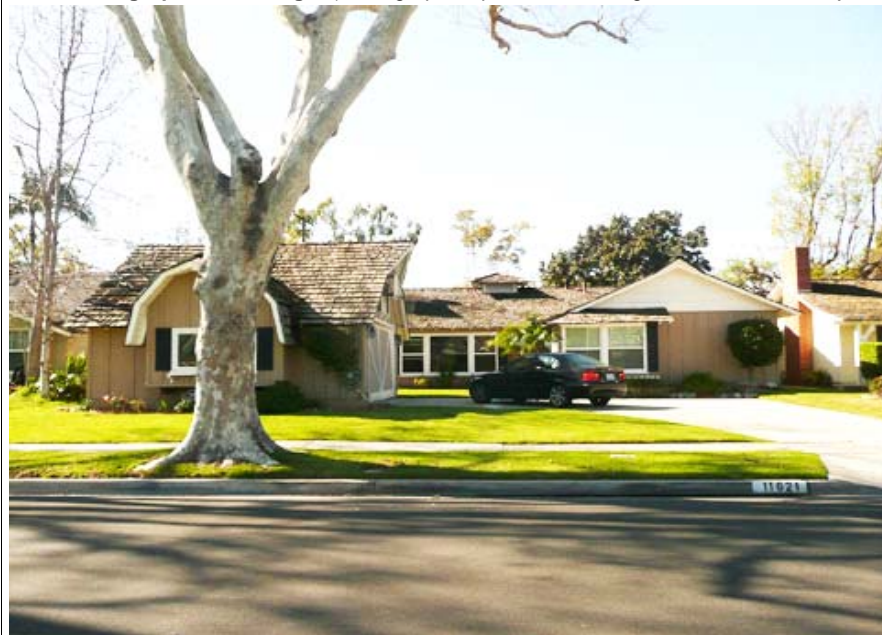
* P3a. Description: (Describe resource and its major elements. Include design, materials, condition, alterations, size, setting, and boundaries.)
The one-story Ranch style building is 'L'-shaped in plan. The cross gabled roof, with flared gable heads, is clad in wood shingles. A cupola is centrally located on the roof crest. The front-facing gable is accented with barge board, and is clad in horizontal wood siding. The exterior walls are clad in board and batten siding, and smooth textured stucco. A projecting bay partially spans the eastern and southern facades of the northerly bay and is accented with corbels. The windows were replaced with vinyl sash and fixed-pane units. A detached two-car barn-style garage is located in the front of the parcel. The garage is characterized by a front facing gabled roof, with gambrel dormers, clad in wood shingles, a faux hay loft, board and batten siding, and a vinyl sliding window accented with shutters and a flowerbox ledge. The building does not meet the NRHP and CRHR eligibility criteria for the reasons identified on the district record prepared for this subdivision; therefore the building does not contribute to a historic district and is not individually eligible for listing in the NRHP and the CRHR.

P5b. Description of Photo: (View, date, etc.)
Facing the primary façade; 2/10/2010; Photo No. P1030861.jpg

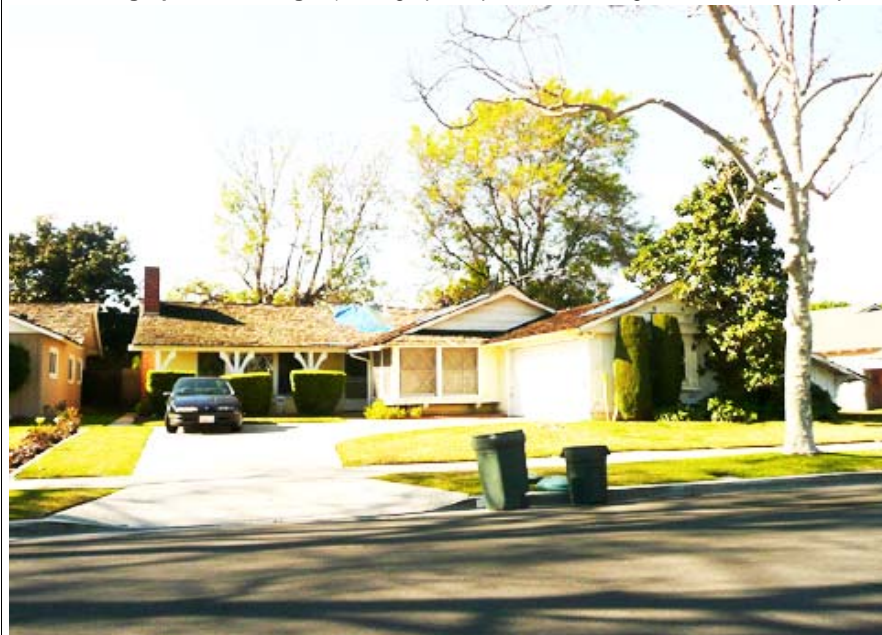
* P3a. Description: (Describe resource and its major elements. Include design, materials, condition, alterations, size, setting, and boundaries.)
The one-story Ranch style building is 'L'-shaped in plan. The cross gabled roof, with boxed eaves and flared gable heads, is clad in wood shingles. A brick chimney is located on the southern façade of the building. The front-facing gables are clad in horizontal wood siding, and the exterior walls of the building are clad in smooth textured stucco. A projecting bay partially spans the eastern and southern facades of the central bay, and is accented with corbels. The diamond-pane wood sash windows appear to be original. The primary entrance is raised, and accessed via a covered porch which spans the southern bay of the primary (eastern) façade. Square wood posts, with brackets, support the porch roof. An attached two-car garage projects from the northern end of the primary (eastern) façade. The front-facing gable of the garage is accented with a dove-cote. Further, the eastern façade of the garage is accented with a diamond-paned sash window flanked by shutters. The building does not meet the NRHP and CRHR eligibility criteria for the reasons identified on the district record prepared for this subdivision; therefore the building does not contribute to a historic district and is not individually eligible for listing in the NRHP and the CRHR.

Facing west; 2/10/2010; Photo No.

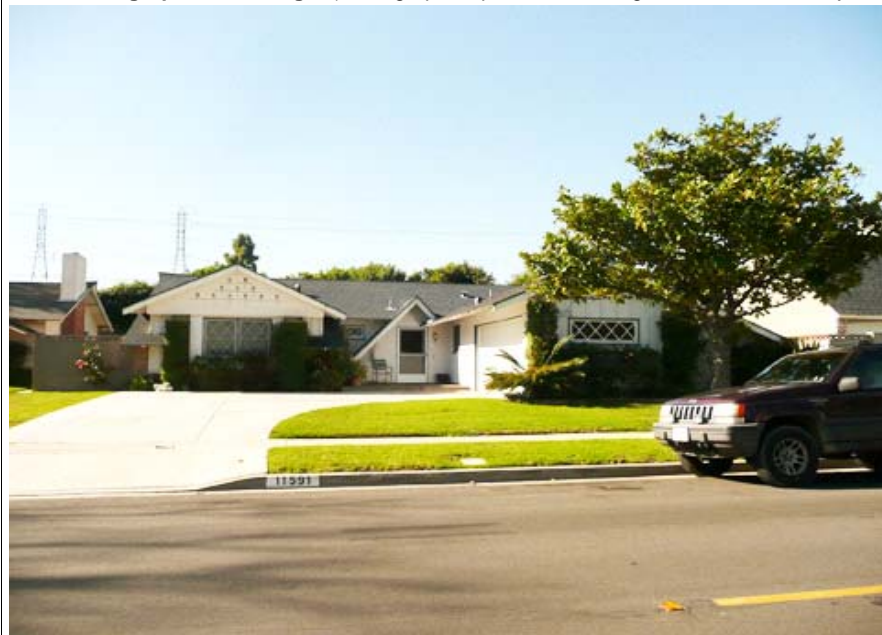
* P3a. Description: (Describe resource and its major elements. Include design, materials, condition, alterations, size, setting, and boundaries.)
The one-story Ranch style building is 'L'-shaped in plan. The cross gabled roof, with boxed eaves and flared gable heads, is clad in composition shingles. The southern front-facing gable is accented with a dove-cote, and the central and northern front-facing gables are asymmetrical. The exterior walls are clad in smooth textured stucco, and vertical board and batten siding. The eastern façade of the attached two-car garage is accented with brick veneer to the water line and brackets. The diamond-paned sash and fixed-pane windows appear to be original. The primary entrance is raised, and is accessed via a flagstone-clad porch. The building does not meet the NRHP and CRHR eligibility criteria for the reasons identified on the district record prepared for this subdivision; therefore the building does not contribute to a historic district and is not individually eligible for listing in the NRHP and the CRHR.

Facing west; 2/10/2010; Photo No.

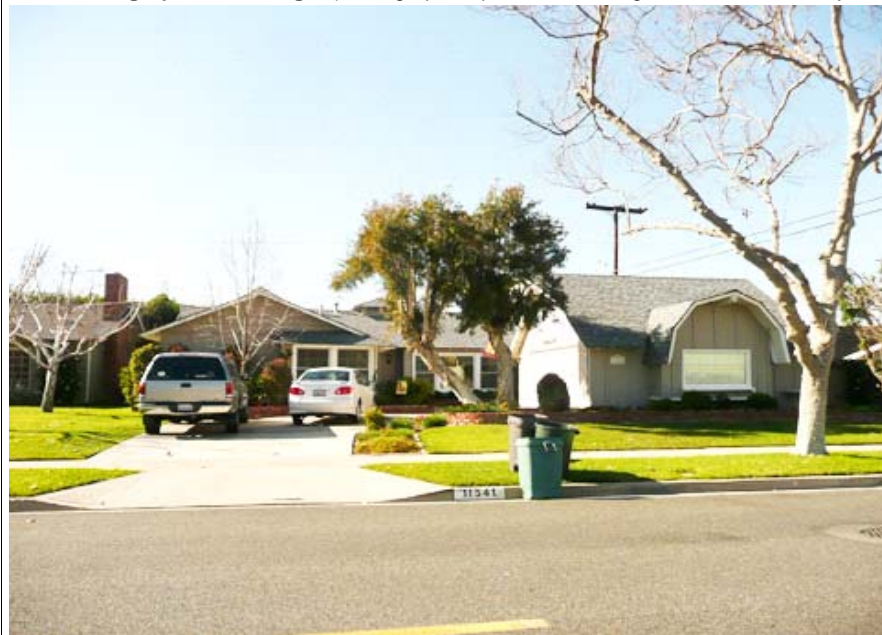
* P3a. Description: (Describe resource and its major elements. Include design, materials, condition, alterations, size, setting, and boundaries.)
The one-story Ranch style building is 'L'-shaped in plan. The cross gabled roof, with flared gable heads, is clad in composition shingles. A cupola is centrally located on the roof crest. The front-facing gable is accented with barge board, and is clad in horizontal wood siding. The exterior walls are clad in board and batten siding and smooth textured stucco. A projecting bay partially spans the eastern and northern facades of the southerly bay and is accented with corbels. The windows were replaced with vinyl sash and fixed-pane units. A detached two-car barn-style garage is located on the front of the parcel. The garage is characterized by a front facing gabled roof, with gambrel dormers, clad in composition shingles, a faux hay loft, board and batten siding, and a vinyl sliding window accented with shutters and a flowerbox ledge. The building does not meet the NRHP and CRHR eligibility criteria for the reasons identified on the district record prepared for this subdivision; therefore the building does not contribute to a historic district and is not individually eligible for listing in the NRHP and the CRHR.

Facing the primary facade; 2/10/2010; Photo No. P1030864.jpg

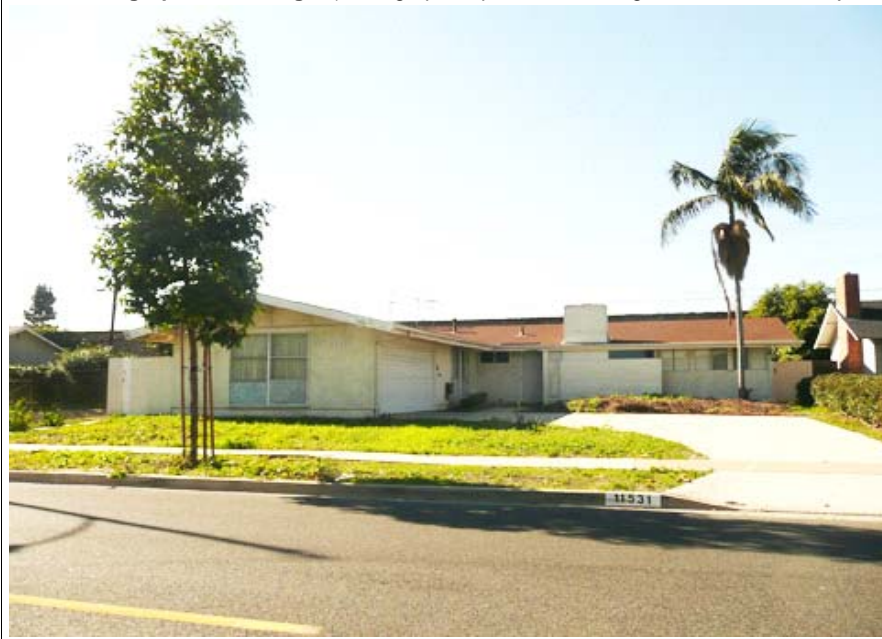
* P3a. Description: (Describe resource and its major elements. Include design, materials, condition, alterations, size, setting, and boundaries.)
The one-story Ranch style building is 'L'-shaped in plan. The cross gabled roof is clad in composition shingles. A brick chimney is prominently located on the northern bay of the primary (eastern) façade. The exterior walls clad in scored stucco, with false timbering in the front-facing gable. The aluminum sliding and fixed-pane windows appear to be original. The primary entrance is raised, and accessed via a small cast concrete porch. The building does not meet the NRHP and CRHR eligibility criteria for the reasons identified on the district record prepared for this subdivision; therefore the building does not contribute to a historic district and is not individually eligible for listing in the NRHP and the CRHR.

Facing west; 2/10/2010; Photo No.

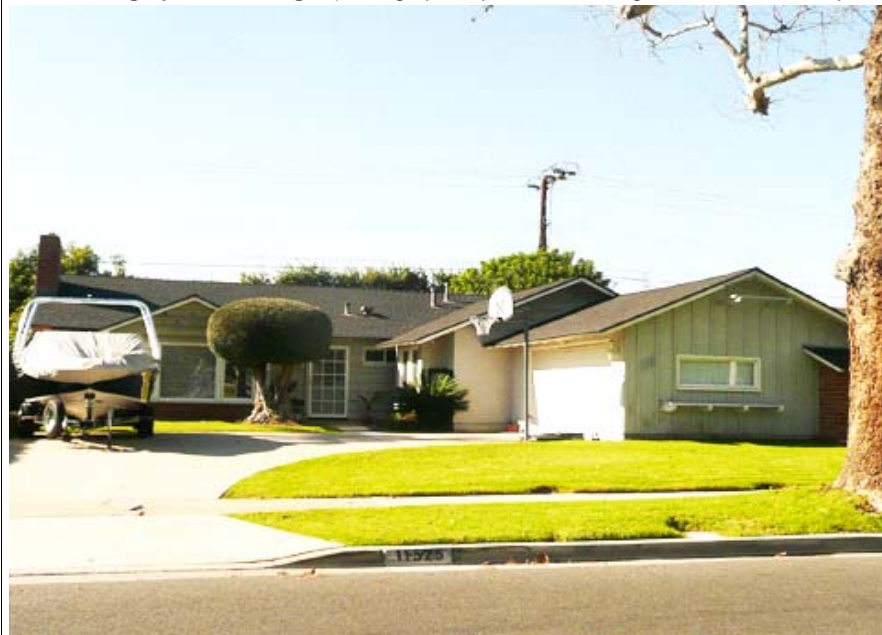
* P3a. Description: (Describe resource and its major elements. Include design, materials, condition, alterations, size, setting, and boundaries.)
The one-story Ranch style building is generally 'L'-shaped in plan. The cross gabled roof, with boxed eaves, is clad in composition shingles. The southern front-facing gable is accented with a doveote, and the northern front-facing gable is accented with a flowerbox ledge. A brick chimney is located on the southern façade of the building. The exterior walls are clad in horizontal wood siding with brick veneer to the water line, smooth textured stucco, and vertical board and batten siding. The windows have been replaced with vinyl sash and fixed-pane units. The primary entrance is raised, and accessed via a small cast concrete porch. The eastern façade of the attached two-car garage is accented with a vinyl sliding window with a flowerbox ledge. The building does not meet the NRHP and CRHR eligibility criteria for the reasons identified on the district record prepared for this subdivision; therefore the building does not contribute to a historic district and is not individually eligible for listing in the NRHP and the CRHR.

Facing west; 2/10/2010; Photo No.

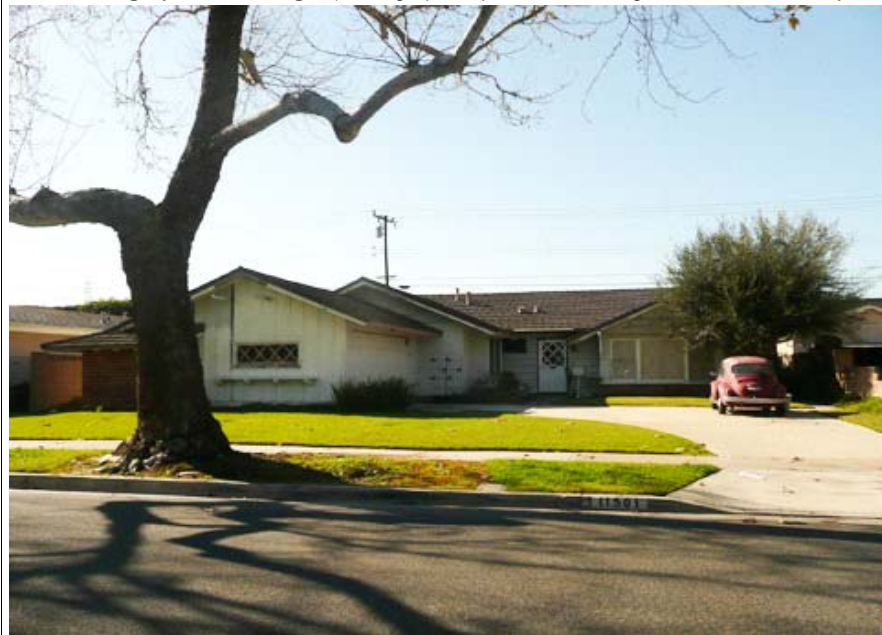
* P3a. Description: (Describe resource and its major elements. Include design, materials, condition, alterations, size, setting, and boundaries.)
The one-story Ranch style building is 'L'-shaped in plan. The cross gabled roof, with boxed eaves, is clad in composition shingles. The southern front-facing gable is accented with the remnants of a flowerbox ledge, and the northern front-facing gable is accented with a dove-cote and brackets. The exterior walls are clad in vertical board and batten siding, smooth textured stucco, and horizontal wood siding. The projecting bay on the northern end of the primary (eastern) façade is accented with brick veneer to the water line. The diamond-pane wood sash and fixed-pane windows appear to be original. The primary entrance is raised, and accessed via a cast concrete porch. The eastern façade of the attached two-car garage is accented with a diamond-paned fixed-pane window with flowerbox ledge. The building does not meet the NRHP and CRHR eligibility criteria for the reasons identified on the district record prepared for this subdivision; therefore the building does not contribute to a historic district and is not individually eligible for listing in the NRHP and the CRHR.

Facing west; 2/10/2010; Photo NO.
